Elkhorn Slough Watershed Permit Coordination Program

2003 Implementation Report

**U.S. Department of Agriculture
Natural Resources Conservation Service and the
Resource Conservation District of Monterey County**

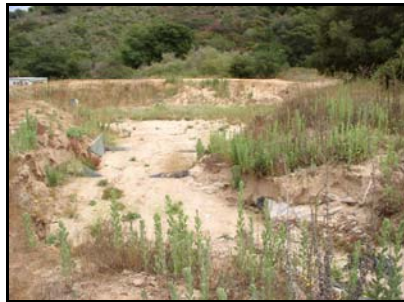
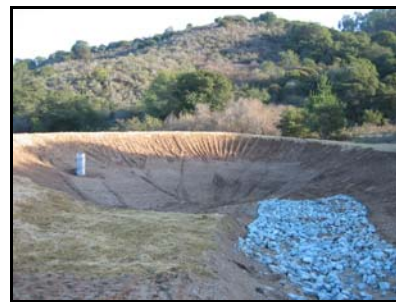
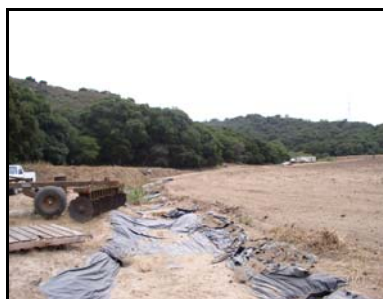
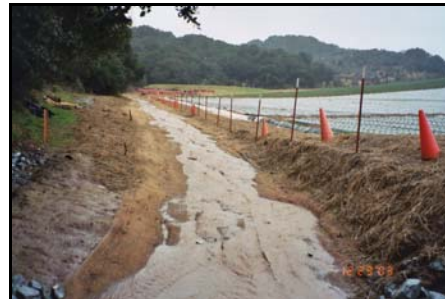
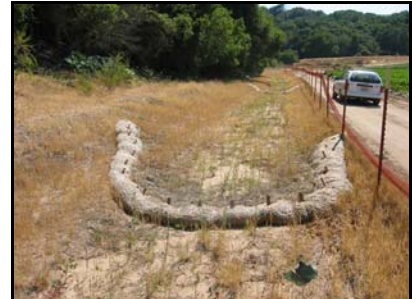
01-004 Before Repair of Water and Sediment Control Basin originally constructed in 2001. **After:** Basin was rebuilt in 2003. This picture shows the riser outlet pipe and the rock energy dissipater inlet for the water flowing into the basin from the fields and farm roads. Monterey Spineflower is located on the lower outside of this structure, and a twenty foot buffer is maintained around this area. **Before:** Channel lined with black plastic carries sediment and water to middle basin.

After: Grassed Waterway implemented in 2003 slows water runoff and traps sediment leaving the fields and road using native grasses and straw wattles for grade stabilization.

One project on the edge of a disturbed site adjacent to upland agricultural fields displayed evidence of the federally threatened Monterey Spineflower (01-004 and 03-005). A twenty-foot buffer zone was established around the site of the Spineflower during construction of a water and sediment control basin and a grassed waterway.

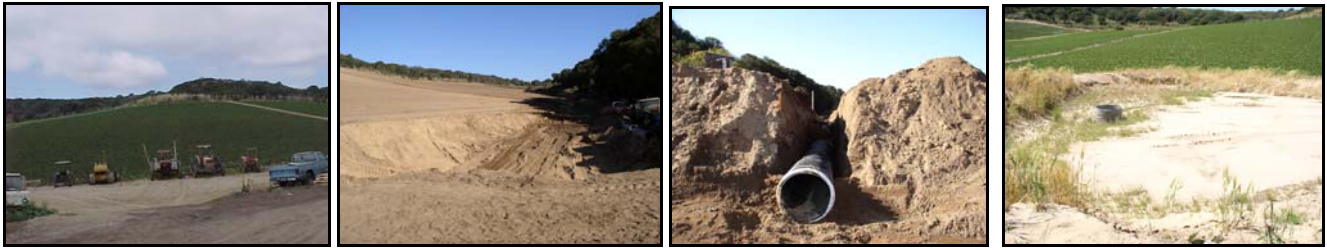
02-002 Before: Location of old sediment basin that had filled in with sand from field and road runoff. **After:** New Water and Sediment Control Basin and Underground Outlet shortly after construction in November 2003. The fourth picture was taken in the spring of 2004 and shows the sediment captured in the new basin. This captured soil will be returned to the fields.

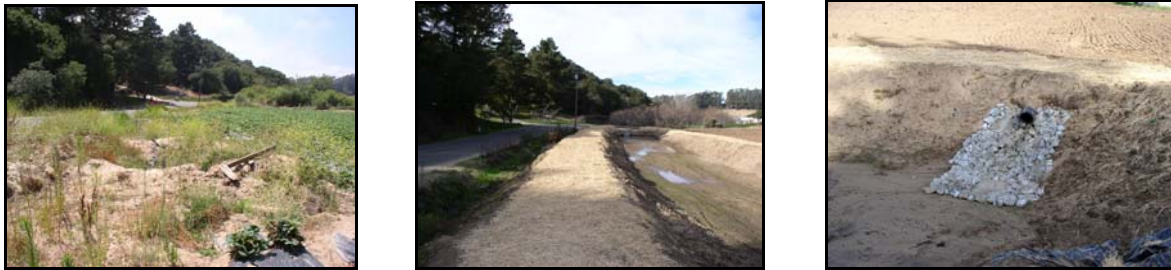
02-004 Before: Roadside drainage and lower field filled with sediment from storm runoff. **After:** New Water and Sediment Control Basin was constructed in the lower part of the farm in 2003. The third picture is the rock energy dissipater that is part of the underground inlet pipe at the upper end of the basin. These structures help capture water and sediment from farm roads and the watershed above the farm.

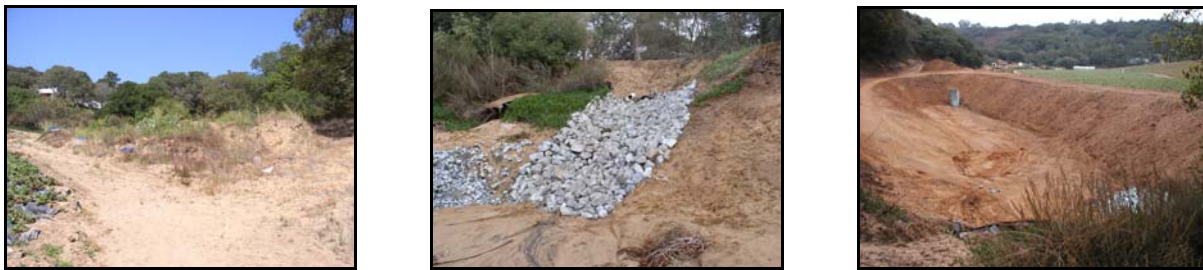
03-002 Before: Farm road and makeshift sediment basin installed. **After:** New Water and Sediment Control Basin with rock energy dissipater and outlet pipe constructed in the upper part of the farm in the Fall of 2003 help capture storm water runoff and sediment from the watershed above the farm.

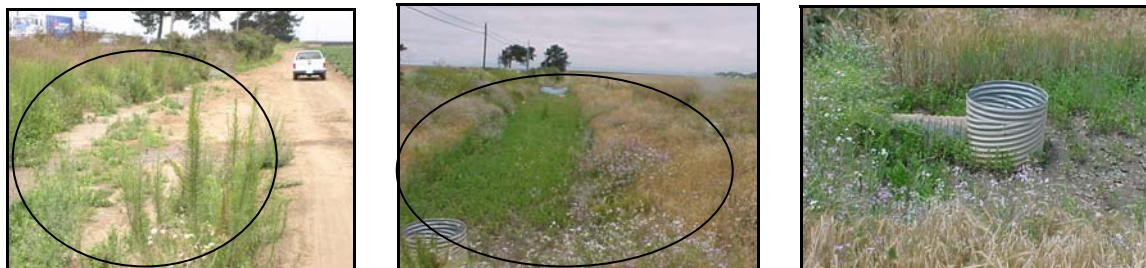
03-003 Before: Sediment from the field and farm roads accumulates next to Highway 1 and continues to flow under the highway through a culvert. **After:** A new Water and Sediment Control Basin slows water runoff and captures sediment before water is released to the culvert under the highway.

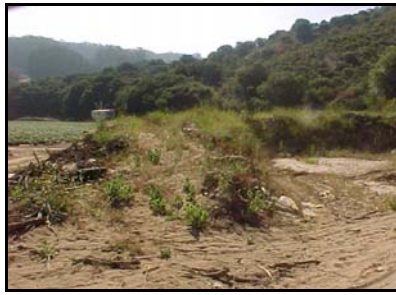
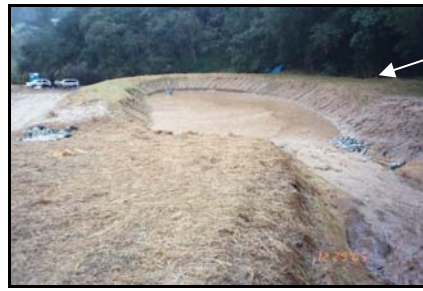
03-005 Before: Shows the poorly constructed middle Water and Sediment Control Basin. **After:** A new basin was designed and installed in 2003, which is suitable for water and sediment retention. This picture shows the basin after a storm event in December 2003 doing its intended job. The third picture is a Grassed Waterway that is above the new basin, which provides a permanently graded and vegetated channel for directing water runoff from the upper basin and field road to the middle basin. The Monterey Spineflower is located just outside of the Grassed Waterway at the upper end (See Arrow).

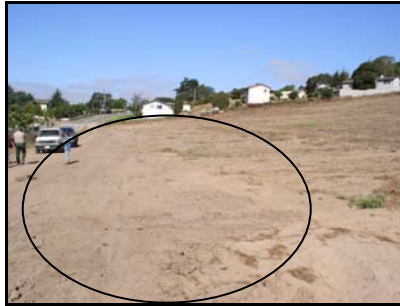
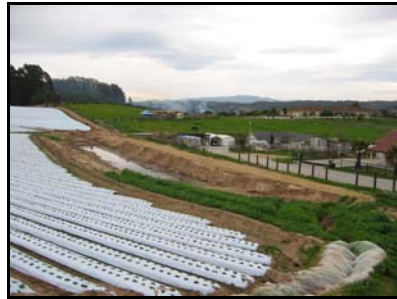
03-007 Before Water and Sediment Control Basin installation and **After:** Showing footprint of the well vegetated basin and the retention capacity for water and sediment that would otherwise enter drainage areas and flood surrounding homes and land.

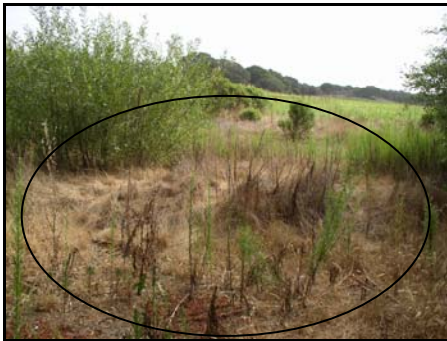
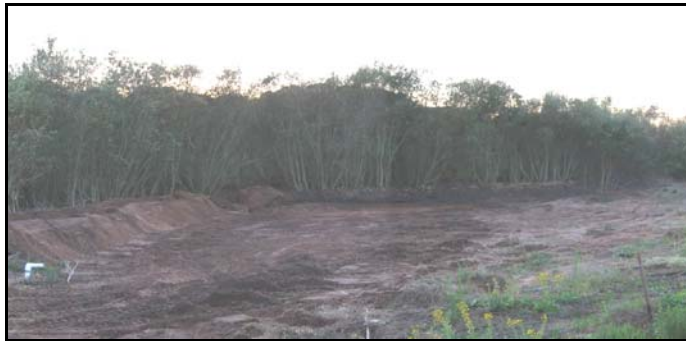
99-007 Before: Sediment Basin had filled in with sediment and willows from a few years of not being cleaned out. The new owners are making a concerted effort to maintain the area as necessary for continued functioning and environmental benefit.
